S1740-AK-RPT-010

U.S. NAVY SALVAGE REPORT EX-USS *PRINZ EUGEN* OIL REMOVAL OPERATIONS

PUBLISHED BY DIRECTION OF COMMANDER, NAVAL SEA SYSTEMS COMMAND

APRIL 2019

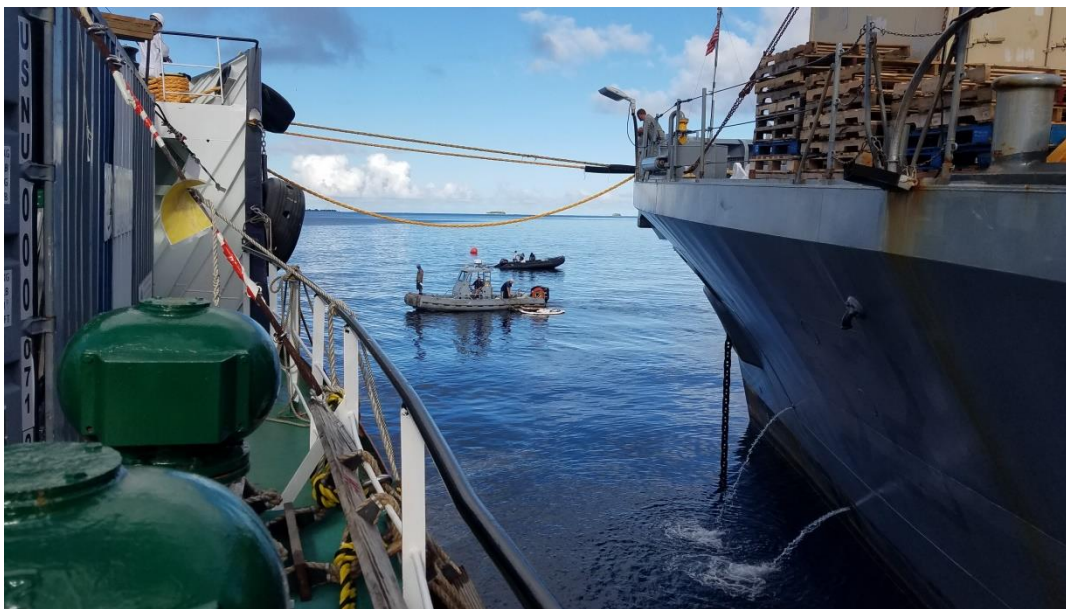
Figure 3.1. Both Primary and Secondary SRTs Out Sweeping Oil with Sorbent Boom

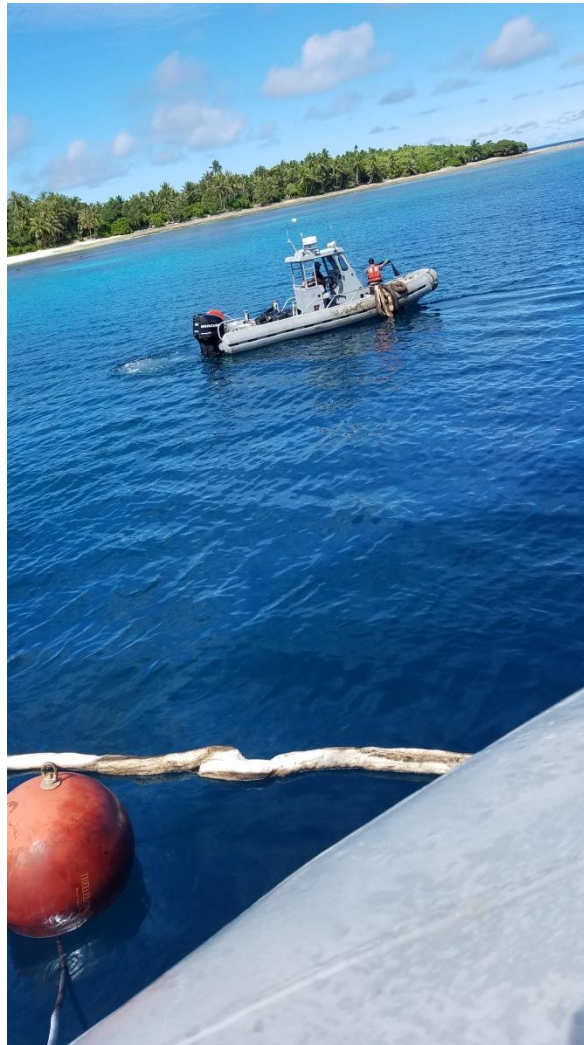
Figure 3.8. Oiled Sorbent Boom Being Recovered Onboard the ESSM 25' Rigid Hull Inflatable Boat (RHIB)

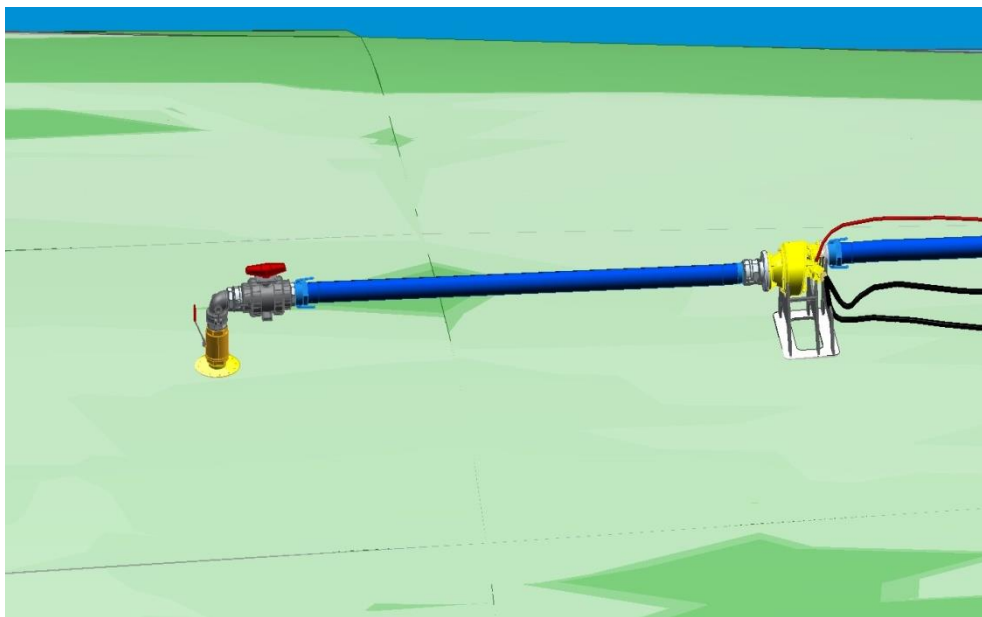
All hoses and camlock connections were to be checked prior to pressurizing the system for integrity. Figure 3.12 shows a hot tap flange with valve, suction hose, and pump assembly. The receiving station OIC was responsible for ensuring that the hose transition was secure and not kinked. One of the inlet deck valves ended up with a crack that was leaking oil into the receiving station cofferdam, and one hose camlock connection became disconnected on the wreck causing a leak which had to be responded to by the SRT, but other than that, all piping remained relatively leak-free for the duration of the project.

Figure 3.12. Hot Tapped Hole, Suction Hose, Pump and Discharge Connection on the Bottom

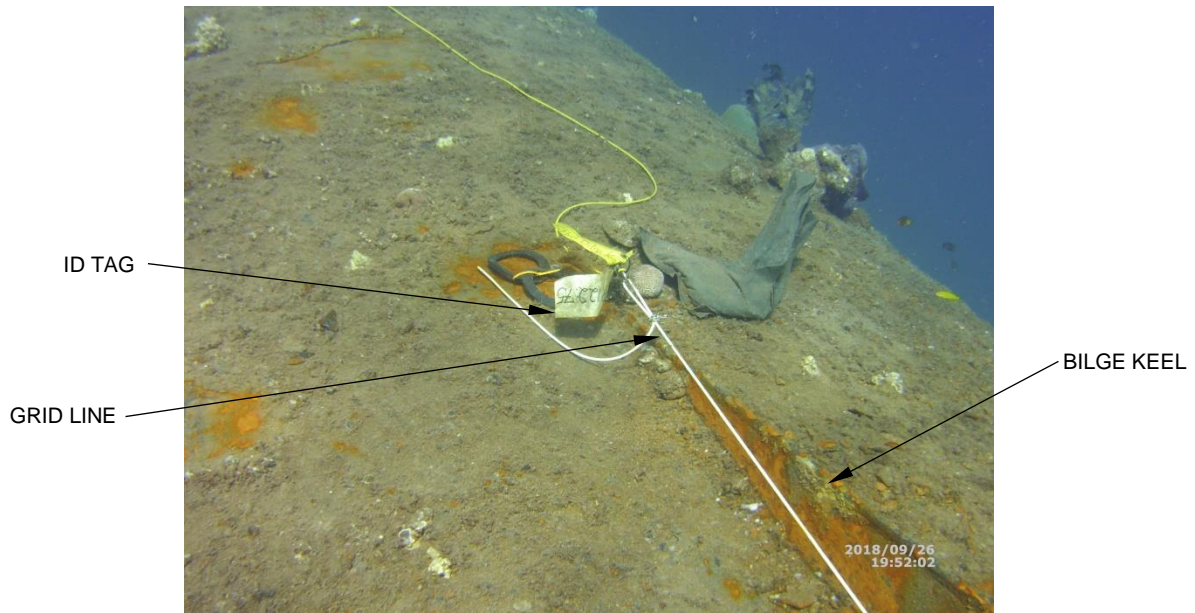
Figure 4.14. Grid Line Termination Point Shown Bolted into the Hull with White Plastic Coated Wire Running Fore and Aft Along the Bilge Keel of the Wreck

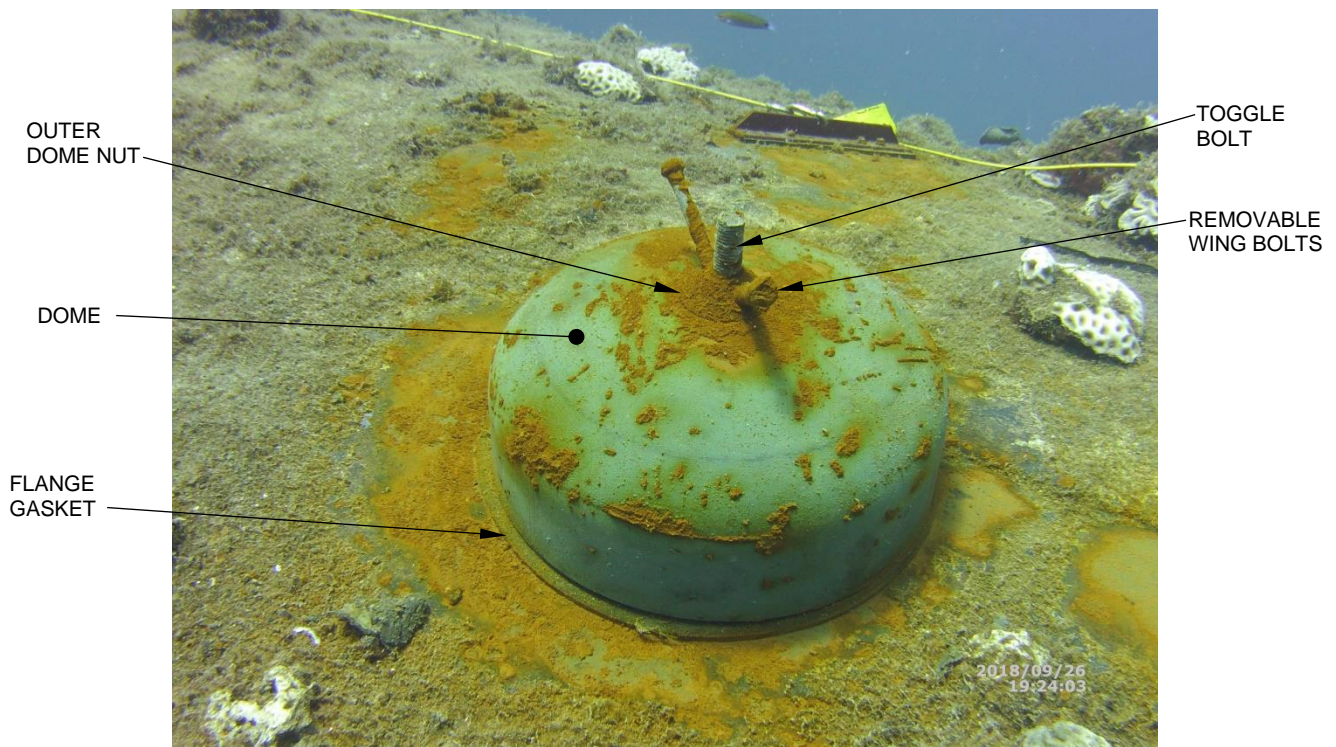
Figure 4.21. Close-Out Cap Shown as Installed.

(Note: this was an early cap installation and later was re-capped using a new set of gaskets including one under the top wing nut. The nut on top of the dome had the wings removed after tightening and a permanent underwater epoxy sealant applied to the threads and bolt holes, so that the cap could not be removed by sport divers.)

The completed tank would then have the valve assembly removed (while holding a plug in the hole) and the hole would then have a toggle assembly and set of close-out caps installed (see Figure 4.21 below). The inner dome (not visible in this photo) was installed and a standard nut with a washer was applied and tightened enough so that the inner dome compressed the gasket at least half way. A larger second dome was then added along with another gasket and an external nut with two bolts sticking out that were used like a wing nut to tighten the nut down onto the external dome, compressing it into the edge of the flange gasket. Thus, tightening this nut would compress the dome onto the oversize gasket located under the original hot tap flange which would seal the tank. Once this was tight and the tank was ready to be permanently sealed, the bolts were removed by unthreading, and the holes and threads of the fastener joint were filled with underwater epoxy. The epoxy paste would then harden to eliminate the possibility of a sport diver being able to remove the nut and dome and re-open a tank.

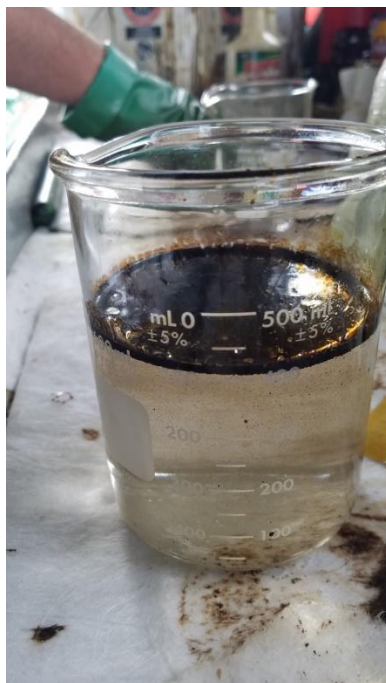
Figure 4.22. Samples taken from the pumped product at the receiving dive station were used to determine the type of oil being recovered, and as a basis for determining where to send the product on the receiving tanker.

This sample shows that only a few percent of NSFO is currently being stripped from the wreck.

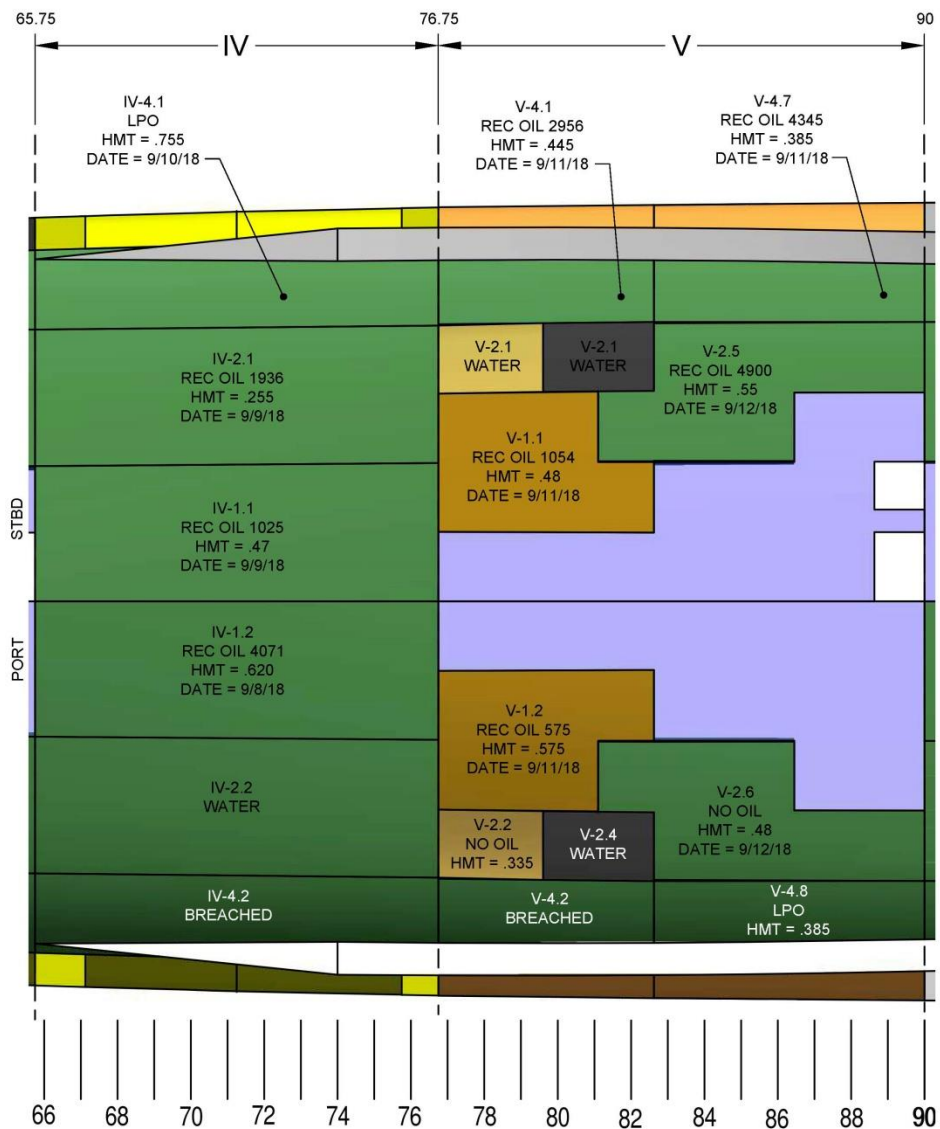
Figure 4.25. Hull Sections IV and V, The First Two Sections of the Wreck to be Hot Tapped and Pumped, are Shown Above

Referencing Figure 4.25, there are 12 target oil tanks in Section V. Testing showed one of them to be breached and three of them to contain only water. All other tanks were hot tapped, but not all other tanks contained oil. Tank V 2.2 (listed as a purified turbine oil tank) was tapped, but no oil was found. Tank V 2.6 (an NSFO tank) was also tapped and contained no oil. Overall five of 12 tanks in this section contained oil, of which two of them contained turbine oil.

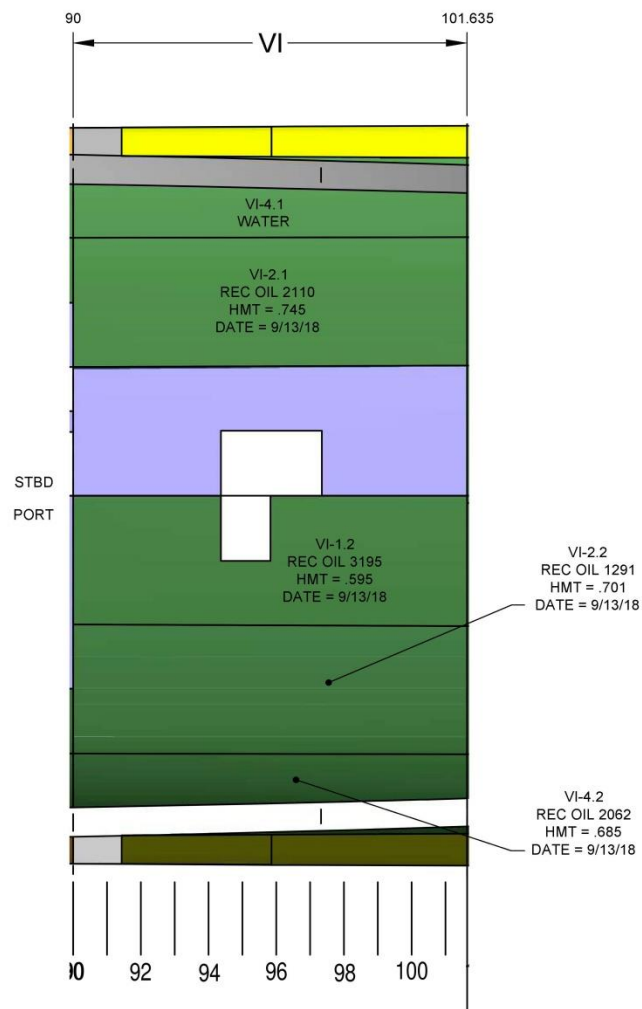
Figure 4.26. External Centerline Tanks Section VI

Section VI had five tanks, one of which tested for water and the other four all had NSFO. Approximately 8700 gallons of oil was removed from this section which amounts to 17% of the full tank capacity of the section (if loaded to 85% of total volume, which was common for loading). Section VII external centerline tanks consisted of 11 tanks, all NFSO except for Tank VII 4.2 which had tested as oil, but produced no oil when pumped. The remaining tanks collectively yielded 19,800 gallons of oil which amounted to 24% of the section's potential fully laden volume. All tanks were pumped down to less than 1% of oil and then shut down for a waiting period of at least 30 minutes, sometimes hours, or overnight to allow oil that was clinging to the internal sides of the hull to separate and rise to the surface of the tank. The tanks in Section VI were each stripped twice; once down to 1% or less and then after a period of waiting they were striped again before they were closed out.

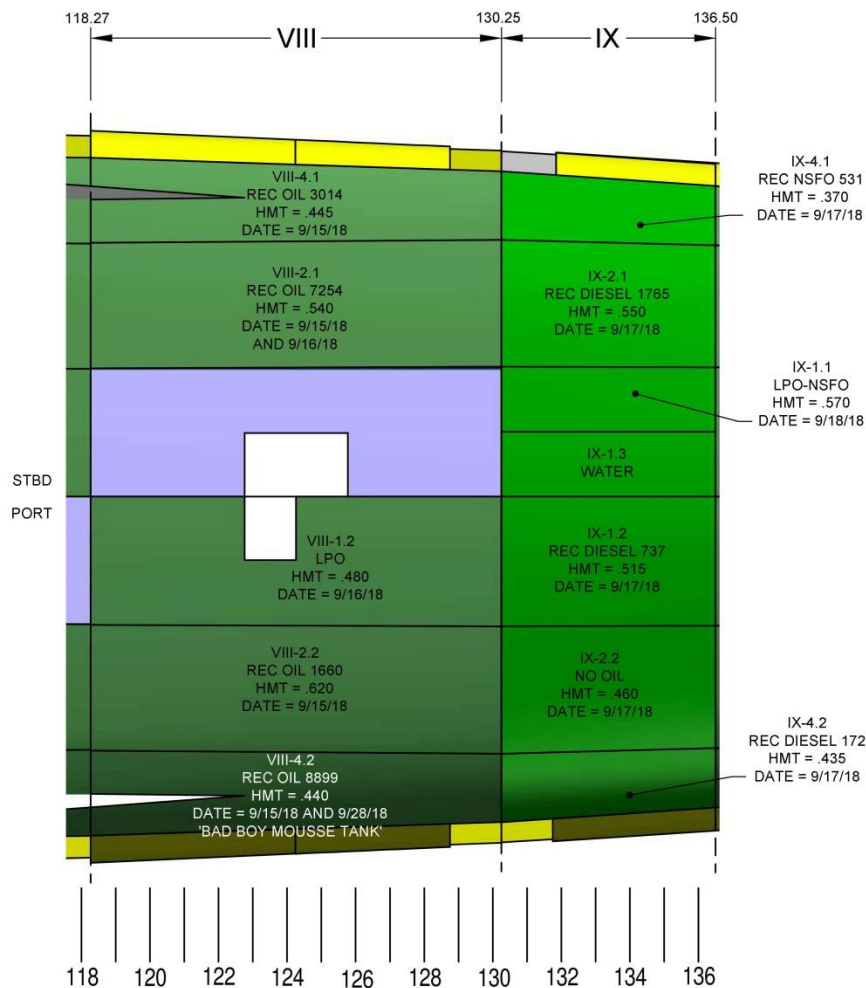
Figure 4.28. External Centerline Tanks Sections VIII and IX

Sections VIII and IX (see Figure 4.28) contained five NSFO tanks in Section VIII and seven diesel fuel tanks in Section IX. There were several new and noteworthy problems that appeared in these two tank sections. It was noted during hot tapping that oil came out of two of the grid installation clips when installing these via screws into the hull. The divers used a two part epoxy made by Devcon to stop the leaks. The Devcon epoxy was in the form of adhesive sticks. Tank VIII 1.2 was re-bolted and re-torqued due to air issues, but had very little oil. Tank VIII 4.1 had to have a second flange put in later in the month (see internal tank section) due to obstructions, but Tank VIII 4.2 had air leaking from the flange bolts.

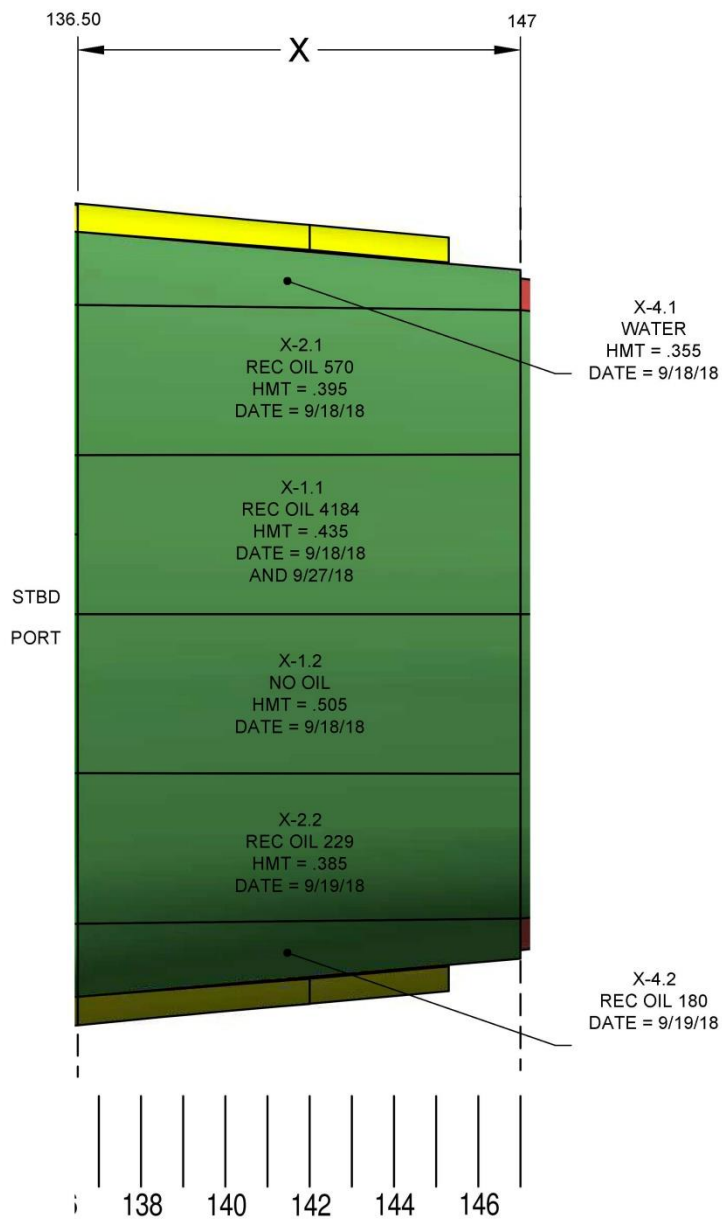
Figure 4.29. External Centerline Tanks Section X

Tank X 1.2 gave up oil and air when the test hole was drilled which indicated there was oil in the tank. When the tank was tapped and all of the air bled out, no oil was recovered and the hole was immediately closed out. Tank X 4.2 was pumped with a small amount of oil recovered, but air issues plagued the entire pumping operation and continually caused the pump to lose suction. The "Pump Through Vent Tube Device" (see Appendix F) was used to help introduce seawater and allow oil to be removed from a tank that had no natural vent.

In summary of hull Sections X and XI, 5200 gallons (10% of full section volume) of oil was recovered from Section X and 32,350 gallons from Section XI which was 28% of the total original full volume of the section and one of the highest section yields of the entire project. Most of the tanks that had oil in Section XI were poorly vented and had air issues. The poor venting was possibly due to the structural damage on the main decks and upward angle in the ship as it now sits upside down on the bottom with vents filled with sand and marine growth or crushed and pinched off altogether. The PE recovery team used the vent device often, and sometimes with the addition of a fire hose, to forcefully inject water deeper into the tank than the tank top suction hole. Other times, a separate vent hole was drilled below the oil line.

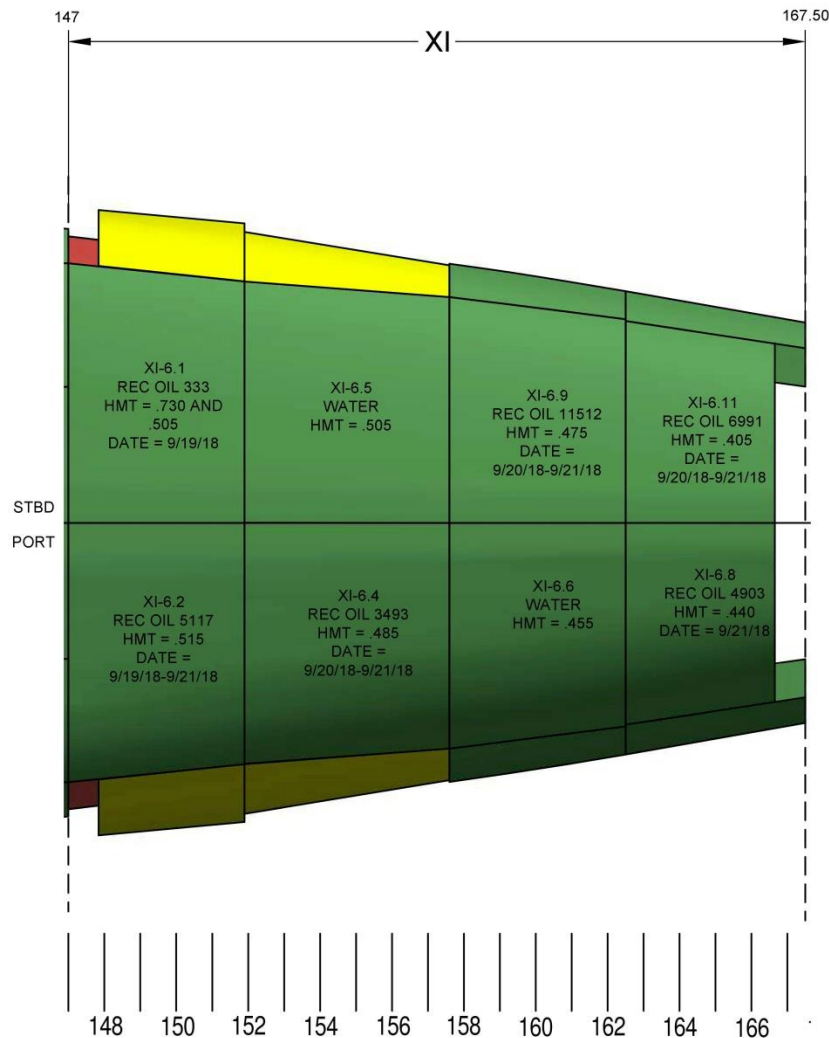
Figure 4.30. External Centerline Tanks Section XI

As described above, Section XI tanks were originally of some concern and thought to be double tanks instead of single tanks, which would have meant 16 hot taps would be required in that section instead of eight. After Tank XI 6.1 was tapped and tested, it was shown that they were indeed single tanks. Other issues in Section XI included the main hot tap hole was drilled outside of the flange (Tanks XI 6.6 and 6.9), and there was a nuisance air bleed problem with Tank XI 6.4. Tank XI 6.2 was another problem tank; it was dubbed the "Drunken Sailor" due to the fluctuating nature of the flow rates and hydraulic pressures as a result of persistent air problems. It was stripped four times over the span of 3 days and finally closed on 21 September. The tank had poor seawater venting and had air trapped in the upper end which was repeatedly being pulled out with the oil and is what created the wild fluctuations in the pump flow rates. There were most likely air pockets trapped behind the

frames in the internal structure that slowly dribbled out as the tank was pumped. Tank XI 6.2 yielded 5100 gallons of oil.

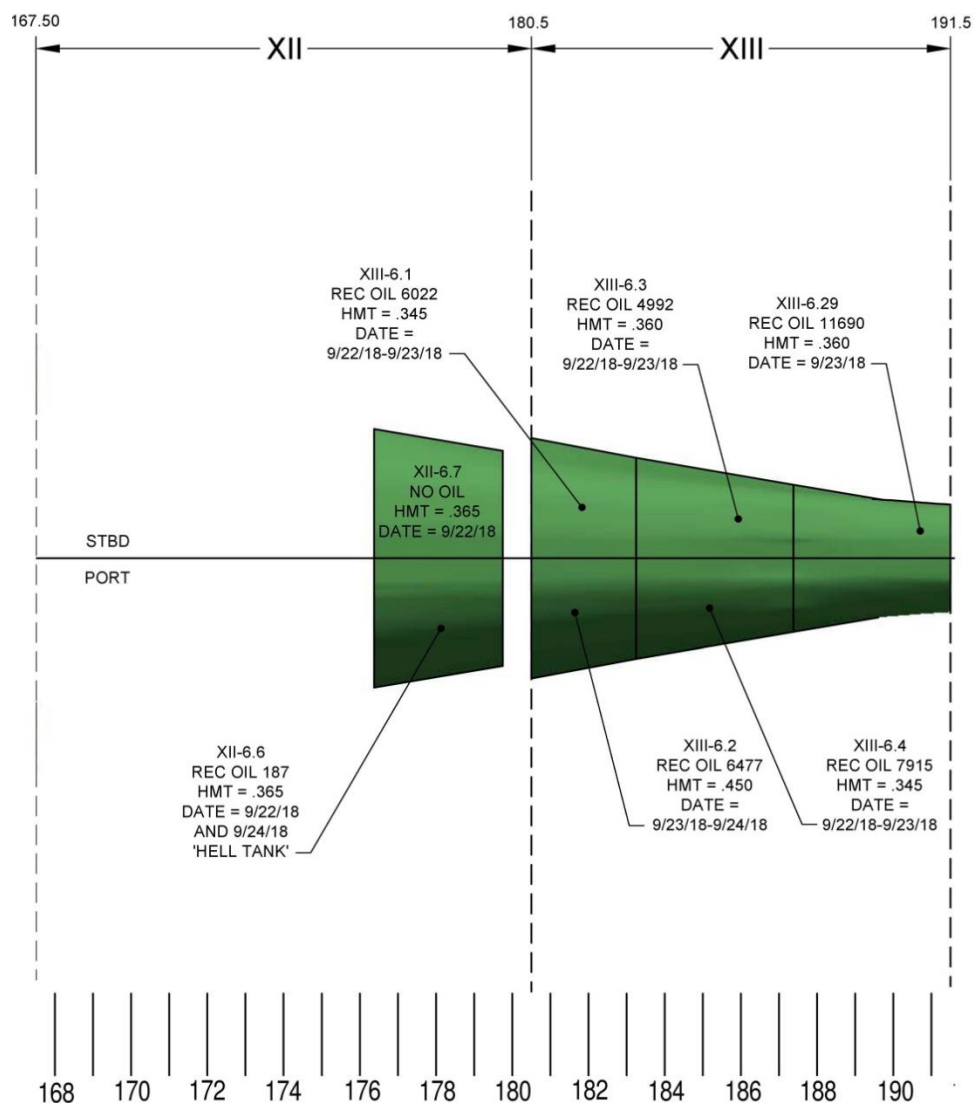
Figure 4.31. Tanks Sections XII and XIII

The recovery of oil from the bow sections was not without excitement and drama as it was rich in oil, but also plagued with changing conditions and conducive to leaks and hot tap flange obstructions (see Figure 4.31). The bow was in approximately 68 feet of water, meaning bottom time was even more of an issue than with other tanks. There were constant leaks emanating from the bow and these leaks had been seeping for many years. The PE team discovered the hard way that in the process of replacing the removed air and oil with seawater, the buoyancy of the wreck was changed and this possibly induced stresses in other locations, which in turn exacerbated the leaking from tanks that were not pumped out yet.

The recovery operations for the Sections XII and XIII in the bow were performed 21–24 September. The PE recovery team had several challenges with the bow sections. There were two hot tap flange leaks which required immediate attention and a changeup of the pump placement on the bottom from one hole to another that also had a leaking flange. This had to be repeated several times and is reminiscent of the game “whack-a-mole”, the circus game where the plastic mole pokes his head up in random holes in a board and the game player tries to whack his head before he drops back into the hole. The bottom line is, in order to relieve the pressure causing the oil to ooze from the leaks, the causes had to be investigated and eliminated, then the pump had to pull the product and displace the same quantity with water on that particular tank. When the PE recovery team started removing air and oil from the bow sections, it was speculated that the change in buoyancy may have caused the bow to settle slightly and open up an existing crack down on the side shell of the bow which allowed oil to leak out at an accelerated rate.

The first problem that came to the attention of the team was a leaking flange on hull Tank XIII 6.3. This leaking flange initiated the launching of the PE Spill Response Team (SRT). While deployed late in the afternoon, the SRT reported seeing very high concentrations of oil (i.e., more oil than what was leaking from the known flange leak). All bottom flanges and taps were checked, and checked again, and then a third time at the bequest of the Project Manager. There was very little leakage found from any of the existing taps and as darkness approached, it was assumed the oil that the SRT team was seeing was oil previously leaked via the flanges and the issue had been resolved. The ship is very narrow in Sections XII and XIII so it was easy to see that there were no leaks coming from the centerline tanks as verified by the surface team via diver helmet cams.

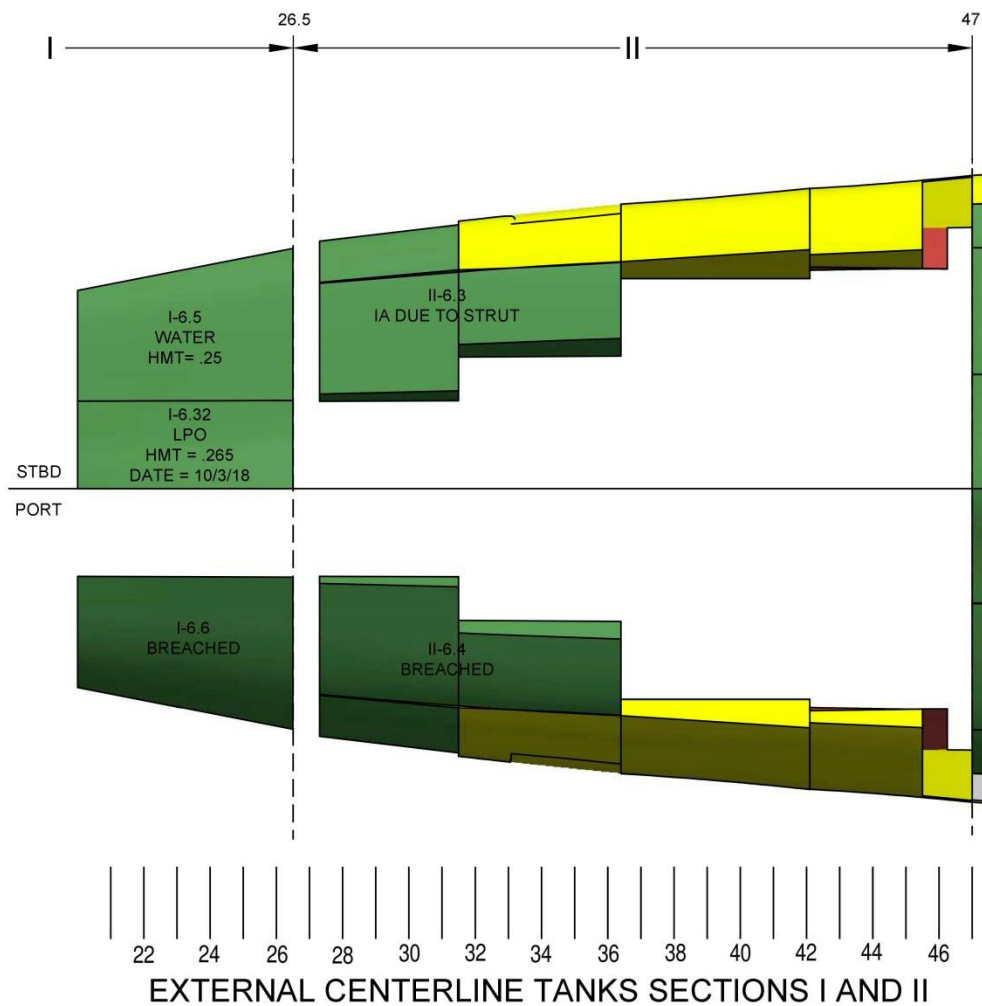
Figure 4.38. Hull Sections I and II - Tanks that were Accessed and Pumped

There were only two centerline tanks in Section II that potentially contained oil, one of those was severely breached and the other was inaccessible due to its location under the propeller shaft strut.

Section I was the aft-most section that potentially contained oil on the ship and only had three potential oil tanks. Tank I 6.6 on the port side was breached and had no oil, and Tank I 6.5 on the starboard side tested negative for oil. The last bunker tank in the section, Tank I 6.32, contained a very small amount of oil that after tapping, pulled at a ratio of about 1% oil to water in the samples taken during recovery. The problem with this tank was that it contained a strong smelling, slightly off color liquid that was initially assumed to be water. As samples were continually taken, it was apparent that there was only a small amount of oil; the team was stripping the tank and only recovered a small percentage of oil in the sample. After several minutes of stripping at a low flow rate, it was noticed that the strong chemical smell was coming from the sample port and from the area around the receiving station. The color of the sample, when viewed in a clear jar, was concerning. It resembled water until it was held to the light and then appeared to be an opaque purple color. A sample jar was taken to the other members of the command team and then a review of drawings was conducted to determine what other tanks were located in the vicinity of the fuel tank (Tank I 6.32). The contents of the tank could not be determined from the drawings. It was decided to secure the tank stripping operation and seal the tank. There were only very small amounts of oil in the tank and it was not worth the risk of taking a large quantity of unknown liquid onboard that could change or contaminate the remaining oil onboard the tanker. Within a few hours of being taken, the sample of purple water had turned to an opaque brown watery color and the small percentage of oil in the top of the sample had settled into the fluid column as wispy tendrils near the bottom of the jar. This lead the team to infer that the unknown liquid had a lighter density than water, but close to that of the oil and once allowed to settle, the chemical rose to the top of the sample jar displacing the oil and water. There was no lab aboard either of the vessels on-site and no immediate means to care for samples that could have been highly flammable and/or highly toxic. Samples were not shipped back to the U.S. and were disposed of in the dirty slops that went to Singapore.

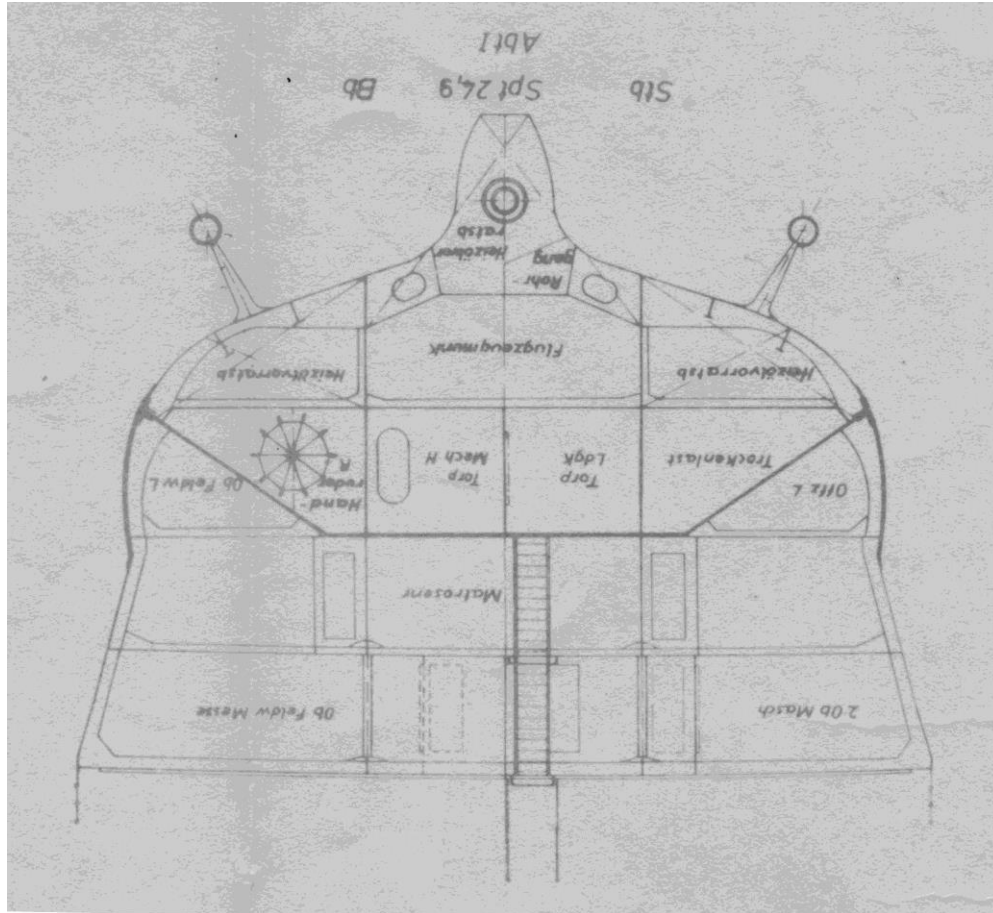
Figure 4.40. Sectional View of *PRINZ EUGEN* at Frame 24.9 Shown Upside Down as the Wreck Lies

The tank immediately below the fuel tank (which would have been above the fuel tank when the ship was upright) is labeled as “FlugzeugmunK” which it is believed translates to “Plane Munitions Hold” (see Figure 4.40 below). It is speculated that the substance that was pumped from the fuel tank could have been any number of liquids including spotter dye (used by ships aircraft to mark locations where suspected submarines were spotted), de-icing fluid, or some type of antifreeze. The bottom line for this tank is that any future activities conducting salvage or recovery on this wreck should proceed with caution if reopening this tank.

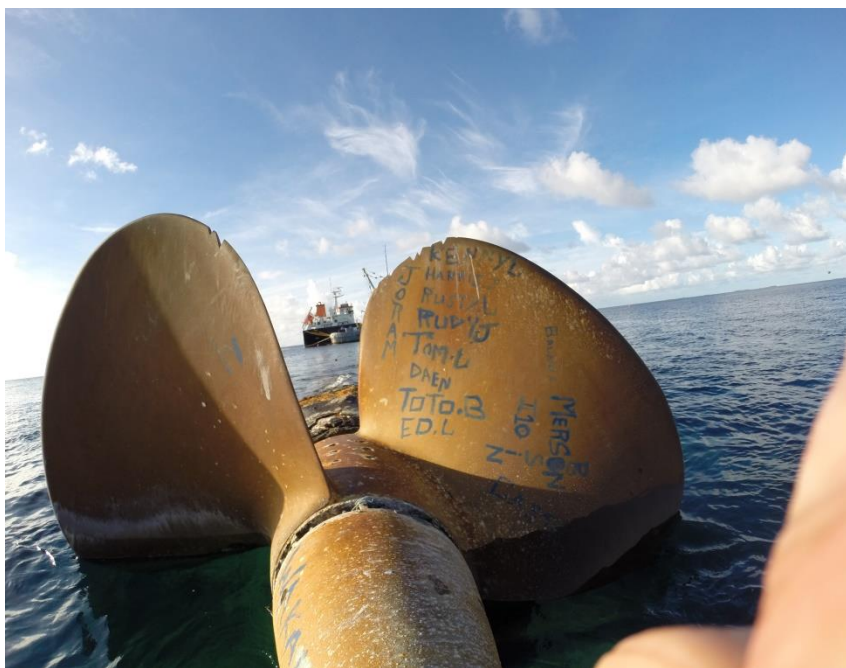
At the time that the oil removal operation was conducted, the ex-USS *PRINZ EUGEN* laid with the bow down at approximately 8–10 degrees from the horizontal. Part of the stern was out of the water; the center propeller and skeg can be seen sticking out of the water (see Figure 5.1). The port side of the ship (lagoon side) was slightly higher than the reef side of ship by an estimate of 5–8 degrees.

Figure 5.1. Center Shaft Propeller View Looking Forward with Recovery Ships in the Background

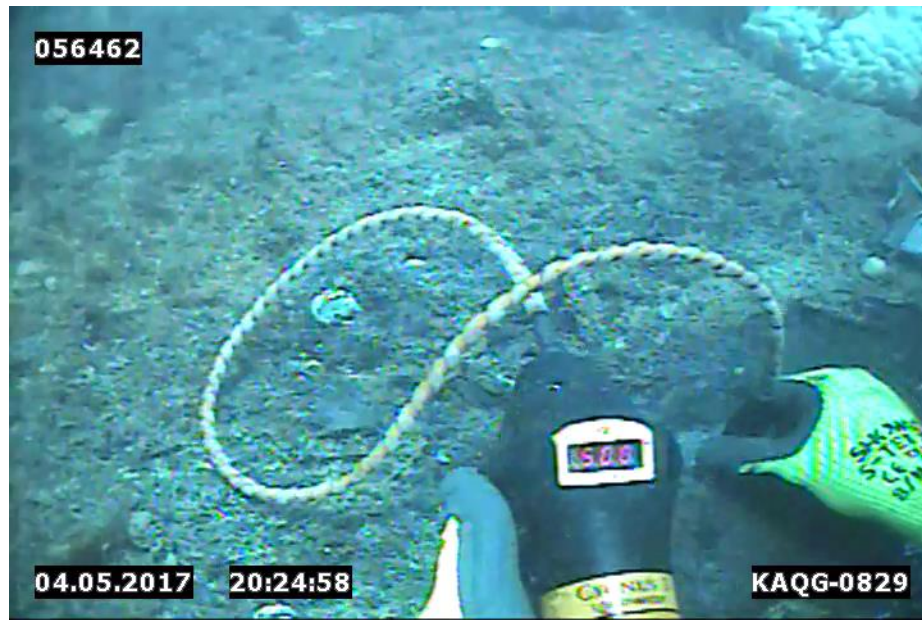
SECTION	NO. OF TANKS	AVERAGE THICKNESS (INCHES)	COMMENTS
I	2	.250	SOME AREAS WERE TOO THIN TO MEASURE
II	NA	NA	NO HULL THICKNESS MEASUREMENTS WERE RECORDED
III	15	.350	
IV	4	.450	
V	9	.450	
VI	5	.690	
VII	11	.475	
VIII	5	.505	
IX	7	.420	
X	6	.410	
XI	7	.410	
XII	2	.365	
XIII	5	.373

Figure 5.9. Diver utilizing a Cygnus underwater ultrasonic thickness gauge to determine the hull thickness in the target area to be hot tapped.
(Photo from 2017 Survey)

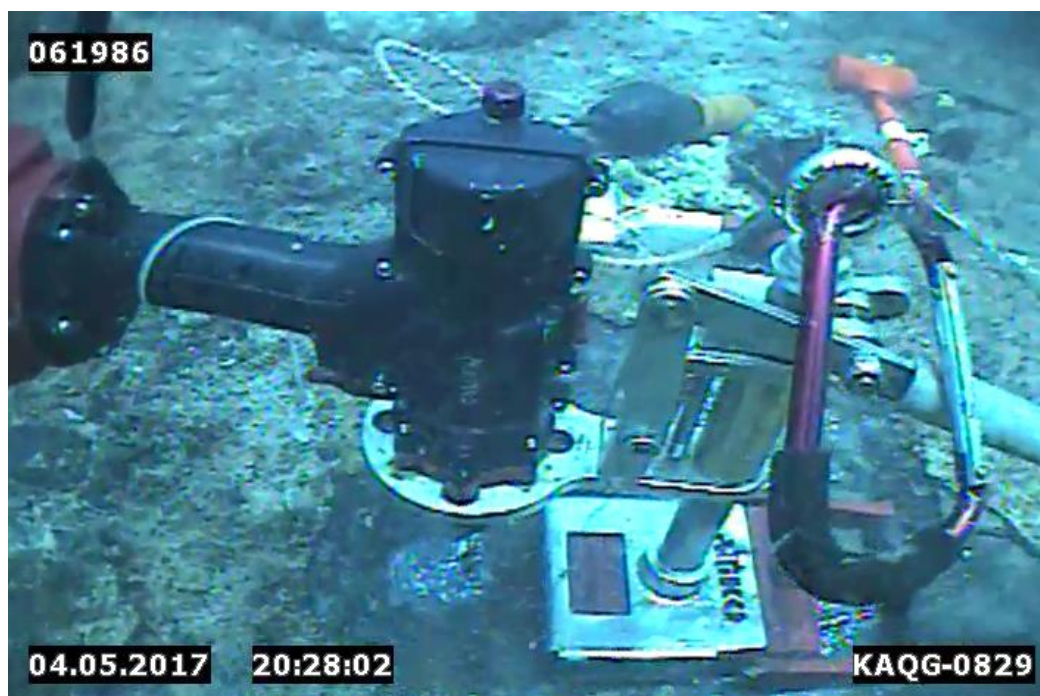
Figure O-1. Diver on Survey Performing a Test Drill using the Miko Magnetic Drill Base and Nemo Battery Powered Submersible Drill
(Photo Taken 5 April 2017)

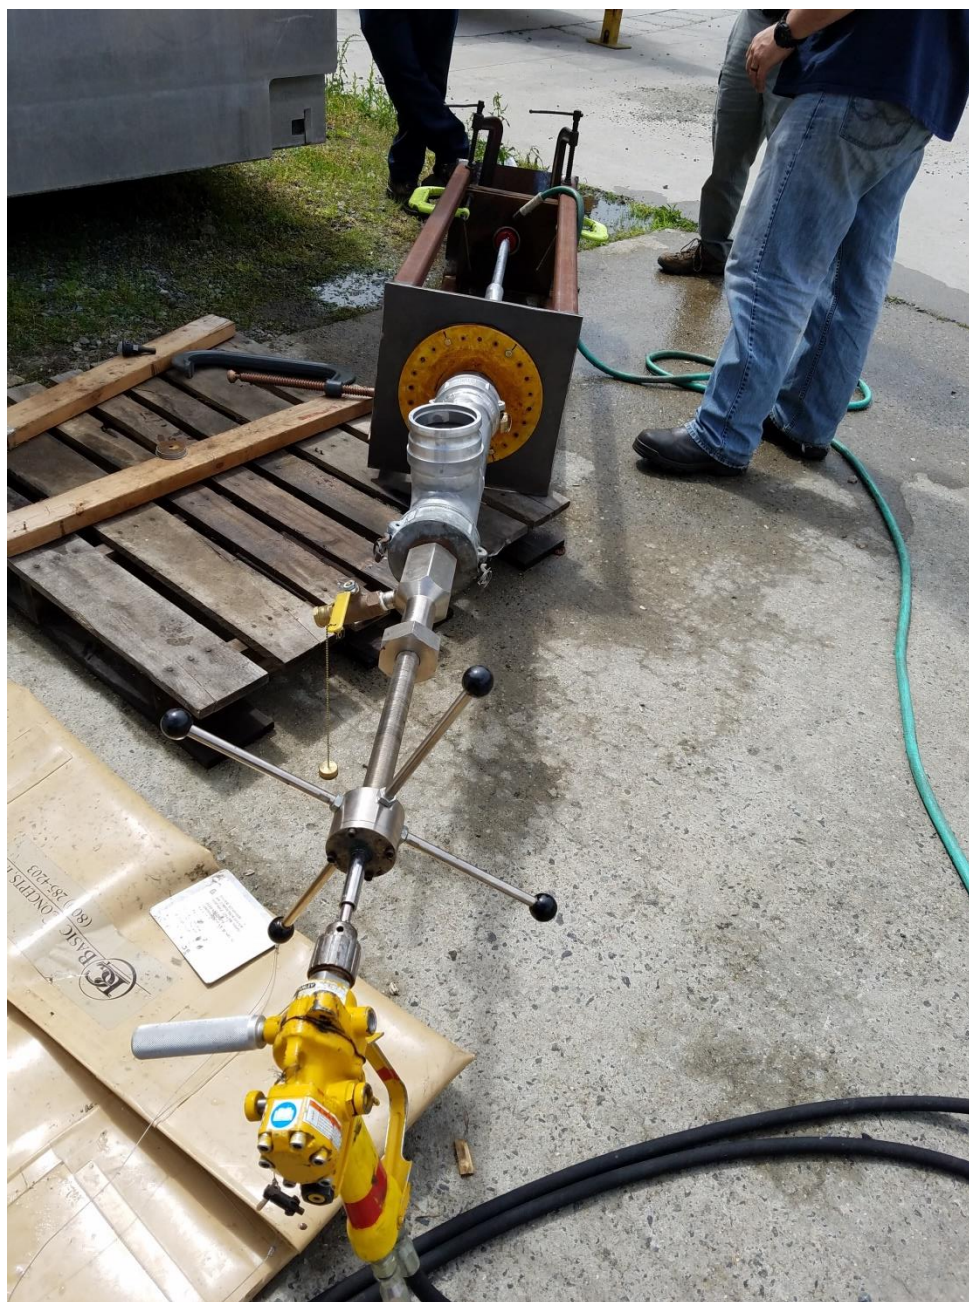
Figure O-3. Testing the Experimental Internal Hot Tap Tool at ESSM Base CAX in
May of 2018
(Photo Taken 15 May 2018)

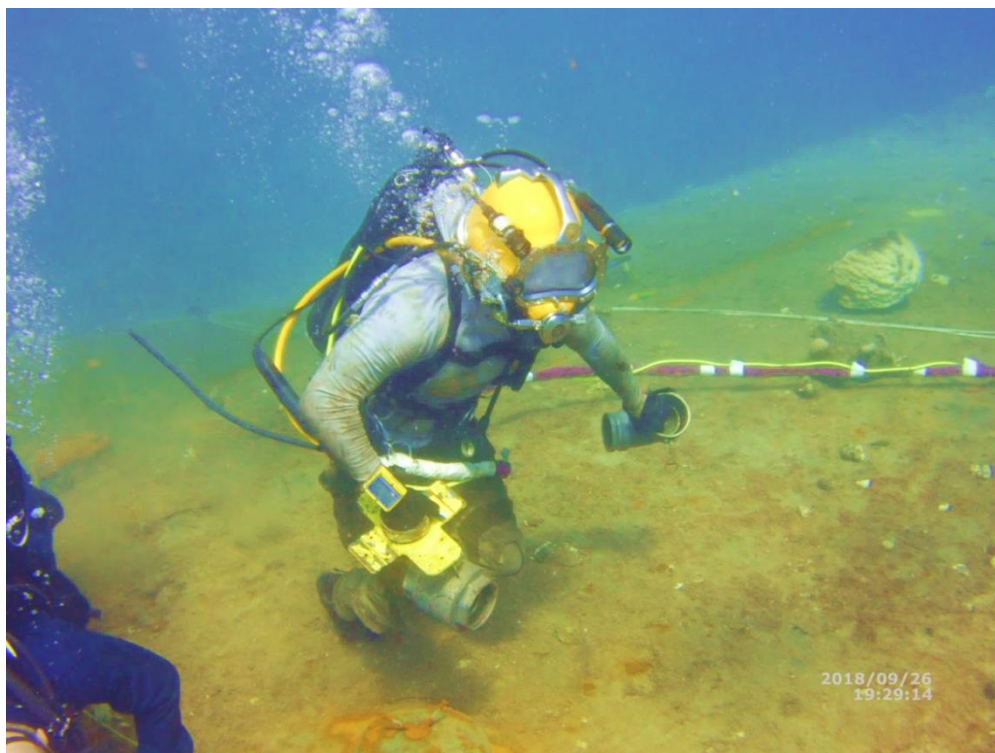
Figure O-17. Dome Enclosure “Close-Out Cap” Installation over Hot Tap Location
(Photo Taken 26 September 2018)
